Study of Inland Wind Effects of Hurricane Fran and Assessment of Inland Wind Model

FEDERAL EMERGENCY MANAGEMENT AGENCY MITIGATION DIVISION

TABLE OF CONTENTS

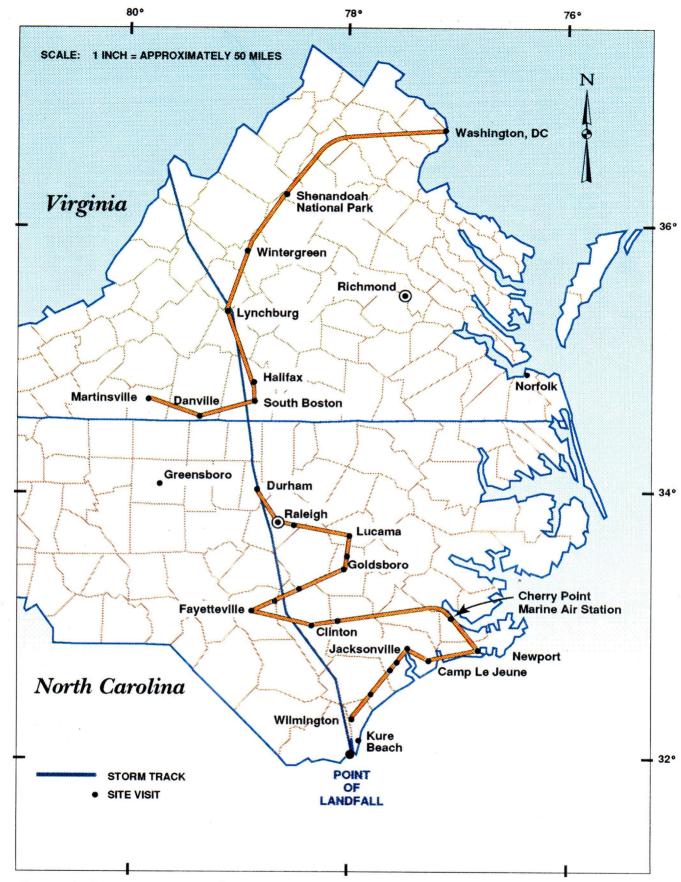
Figure 2-1 Site visit travel routes.

Two G&O employees conducted the site visits. More than 30 sites were inspected, and over 600 miles traveled within an area extending northeast from Wilmington to Durham, North Carolina, and from Martinsville, Virginia, to Washington, DC. Figure 2-1 shows the site visit travel routes, including stops made along the routes. Summaries of the site visits are provided in Appendix B.

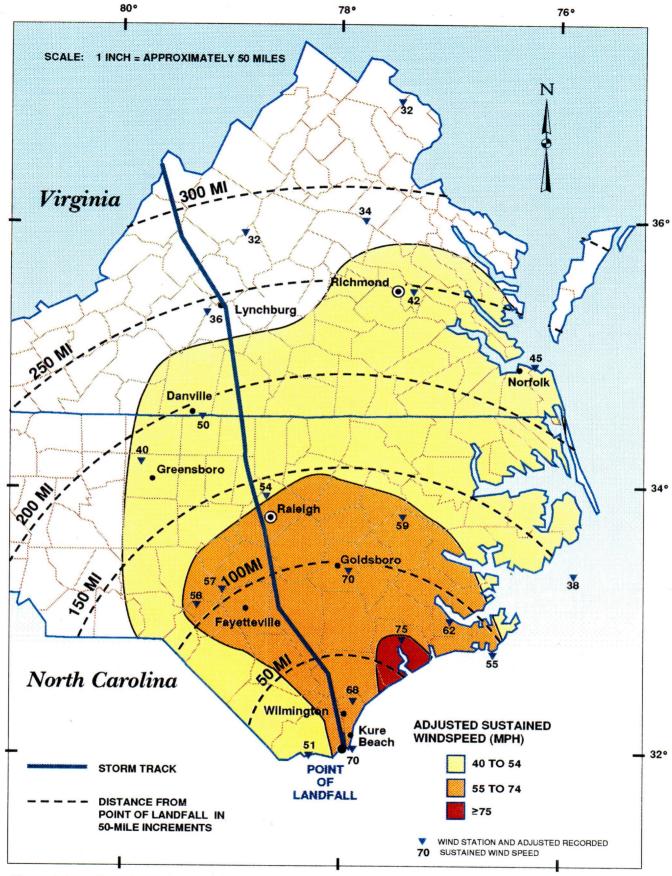
Figure 4-1 Adjusted sustained wind speeds.

Figures 4-1 and 4-2 show the sustained and peak gusts plotted on a map of the affected area. The boundaries of the wind field areas have been interpolated between the reporting stations shown on the maps. Recorded wind speeds from stations reporting throughout the storm have been used. In addition, damage observed along the site visit travel routes was used as an indication of wind speed. The legends for the maps correlate to the Beaufort Scale and gale-force, storm-force, and hurricane-force conditions. The lower wind speed value in Figure 4-2 (47 mph) represents a strong gale-force wind on the Beaufort Scale and was chosen as the lower boundary because 40-mph peak gusts were prevalent throughout the entire states of North Carolina and Virginia.

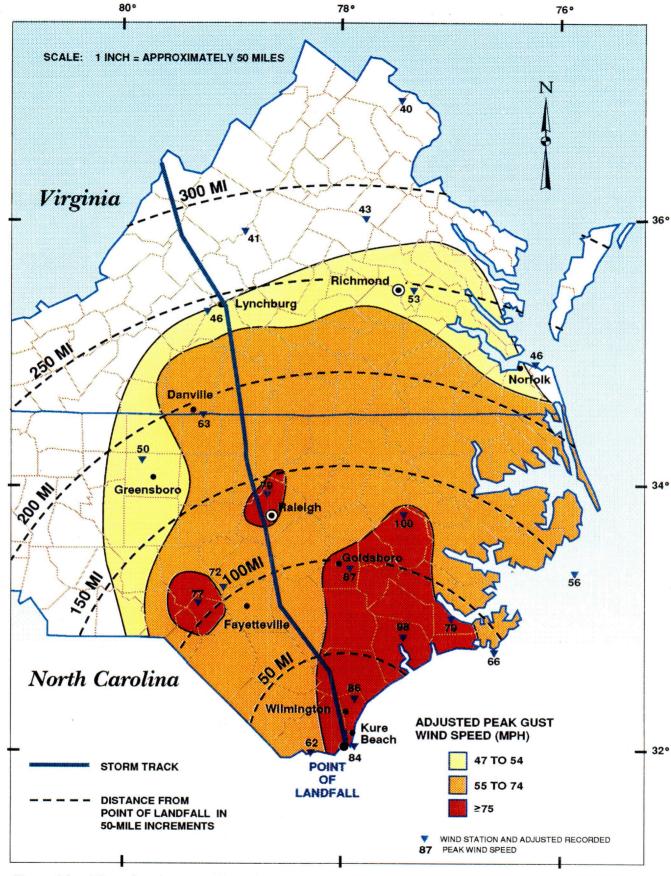
Figure 4-2 Adjusted peak gust wind speeds.

The conclusion from these wind speed data is that the 1-minute sustained wind speed over water at the time of landfall was probably between 90 and 100 mph. A storm with wind speeds in this range would be a Category 2 hurricane on the Saffir-Simpson Scale. The peak gusts along the coast appear to have reached 110 to 120 mph.

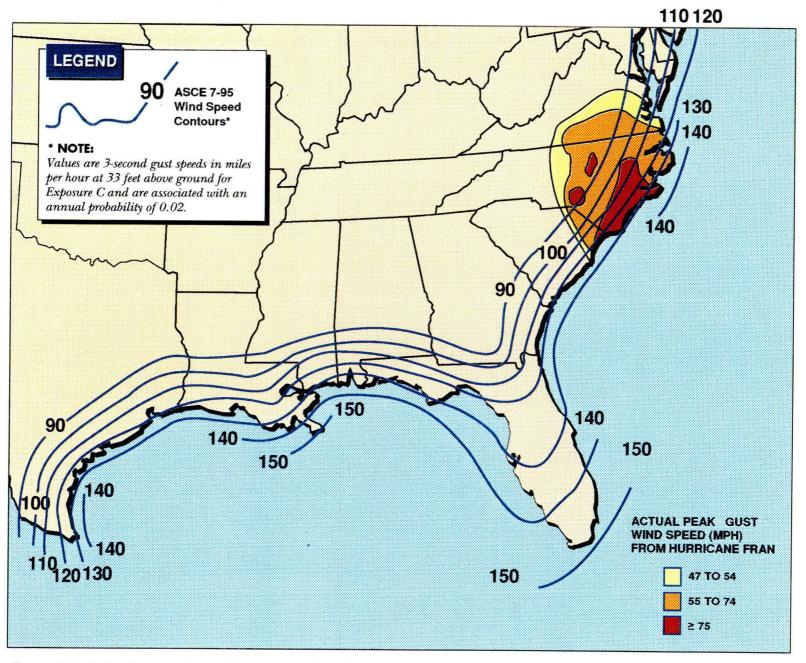
Figure 4-4 Inland extent of actual peak gusts from Hurricane Fran superimposed on portion of ASCE 7-95 wind speed map.

It should be noted that the recorded speeds shown for the 3-second peak gust on the wind map in ASCE 7-95 were not exceeded anywhere during Hurricane Fran. See Figure 4-4 for the portion of the ASCE wind map that pertains to the area affected by Fran.

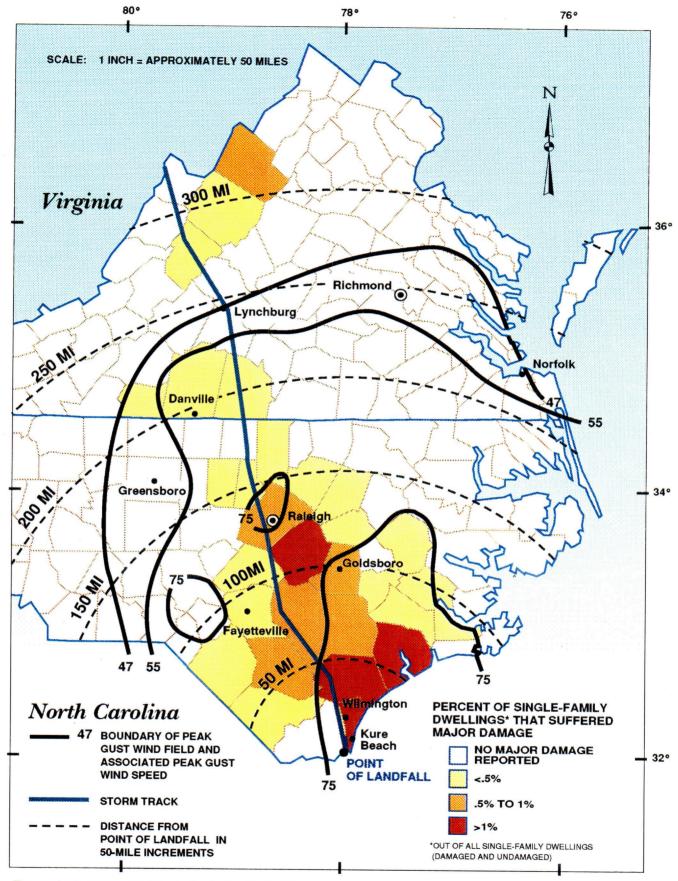
Figure 4-15 Major damage to single-family dwellings.

Figure 4-15 compares the structural damage percentages by county for single-family dwellings in North Carolina and Virginia with the peak gust wind fields illustrated in Figure 4-2. Note there are only four counties with damage levels in excess of 1 percent. Three of these counties are on the Atlantic coast, where much of the sustained damage was from storm surge and flooding. For example, the percentage of homes damaged in Pender County, North Carolina, was almost 10 percent.

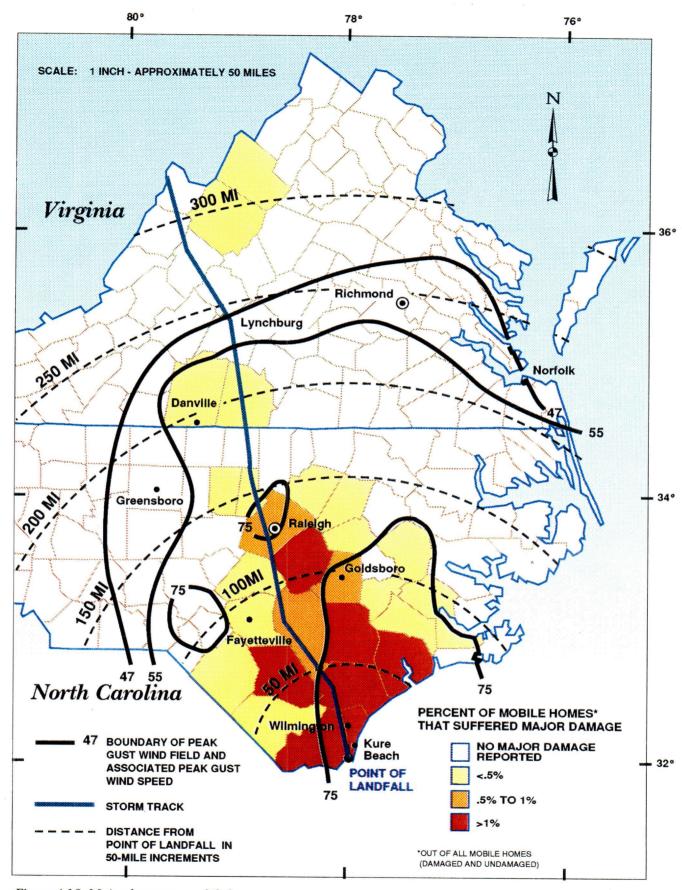
Figure 4-18 Major damage to mobile homes.

Figure 4-18 compares the structural damage percentages by county for mobile homes in North Carolina and Virginia with the peak gust wind fields illustrated in Figure 4-2. In seven counties, the damage levels exceeded 1 percent.

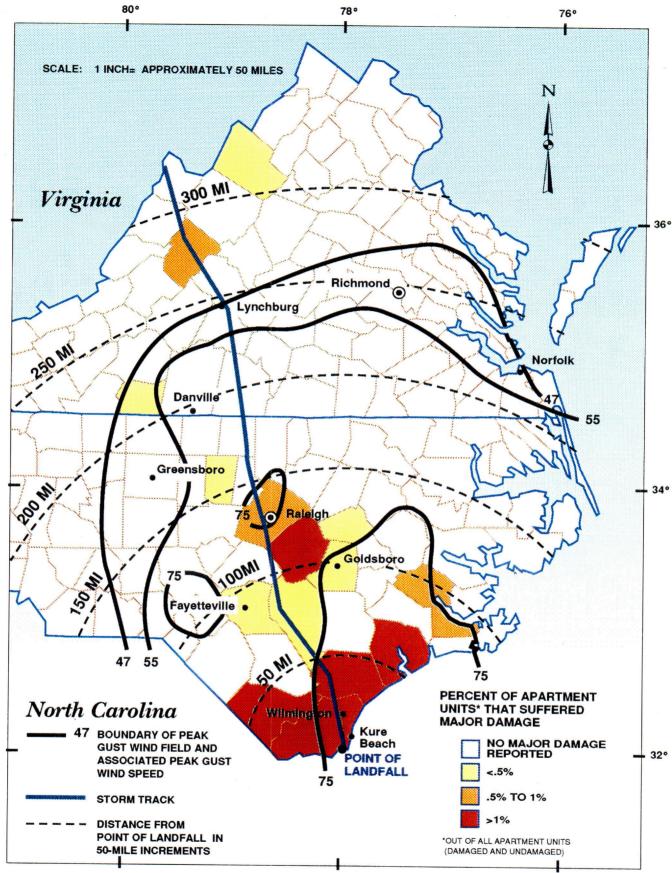
Figure 4-19 Major damage to apartment units.

Figure 4-19 compares the structural damage percentages by county for apartment units in North Carolina and Virginia with the peak gust wind fields illustrated in Figure 4-2. The overall damage level to apartment units was less than 1 percent (0.72 percent).

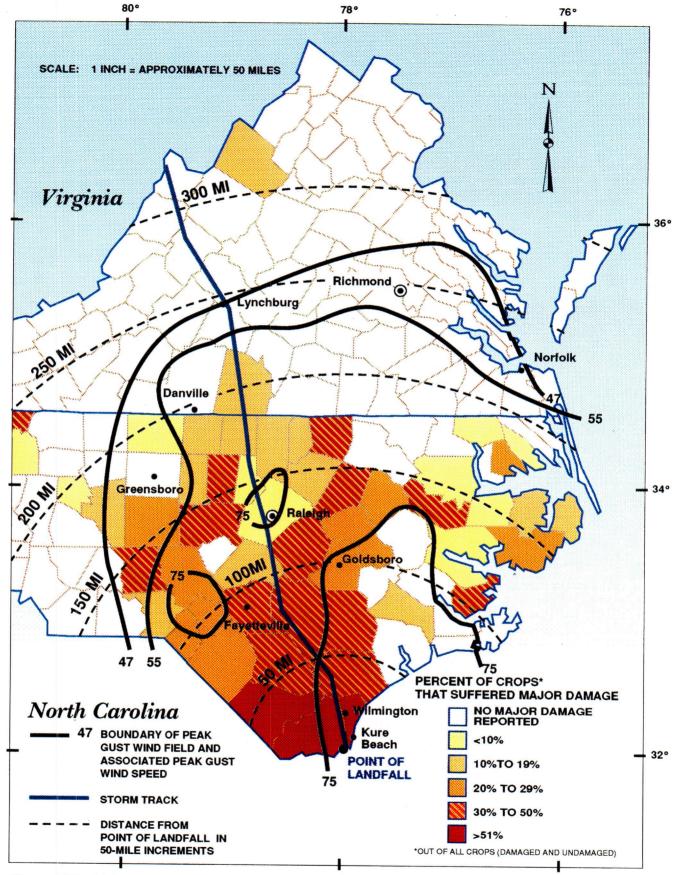
Figure 4-26 Major damage to crops (including timber).

The North Carolina State Farm Service Agency Office of the U.S. Department of Agriculture provided information regarding crop losses per affected county. The primary losses were in cotton, corn, soybeans, and timber. In Jones and Wake counties, the losses were primarily in timber, a total loss of approximately 43,000 acres out of almost 600,000 acres.

Crop damage data by county for North Carolina and Virginia are presented in Appendix F. Figure 4-26 compares these data with the peak gust wind fields illustrated in Figure 4-2. Figure 4-27 illustrates the type of damage that occurred to pine trees near Raleigh, North Carolina. The wind that caused the pictured damage had a sustained speed of approximately 50 mph and came from a northeasterly direction.

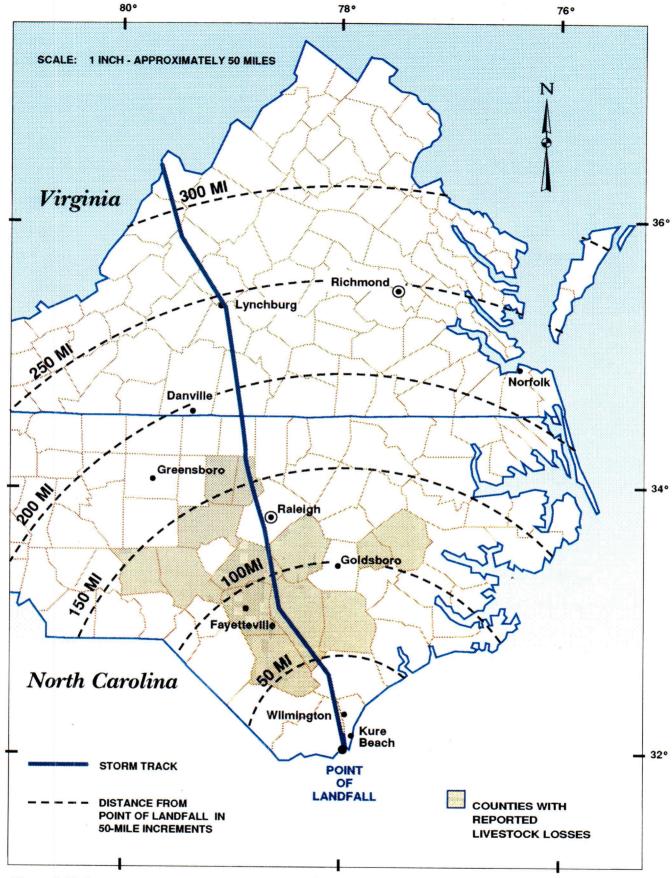
Figure 4-28 Livestock losses.

There was also loss of livestock (see Figure 4-28), but the data are not normalized and thus are not included in the overall evaluation of storm damage in this report. It is important to note that loss of livestock and other farm animals can occur during a severe wind event.

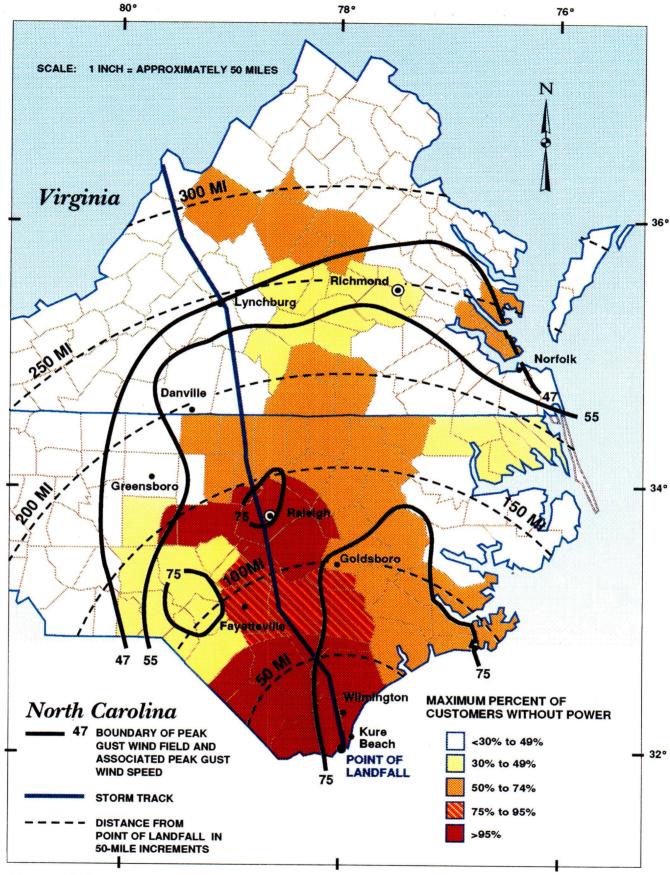
Figure 4-30 Power outages.

Figure 4-30 compares power outages, in maximum percent of customers without power, by county in North Carolina and Virginia with the peak gust wind fields illustrated in Figure 4-2. The area to the right of the storm track clearly had more customers without power than did the area to the left. It should be noted that because of the geographic distribution of power service areas, the number of customers affected by power outages probably included some who were not in the swath of the storm.

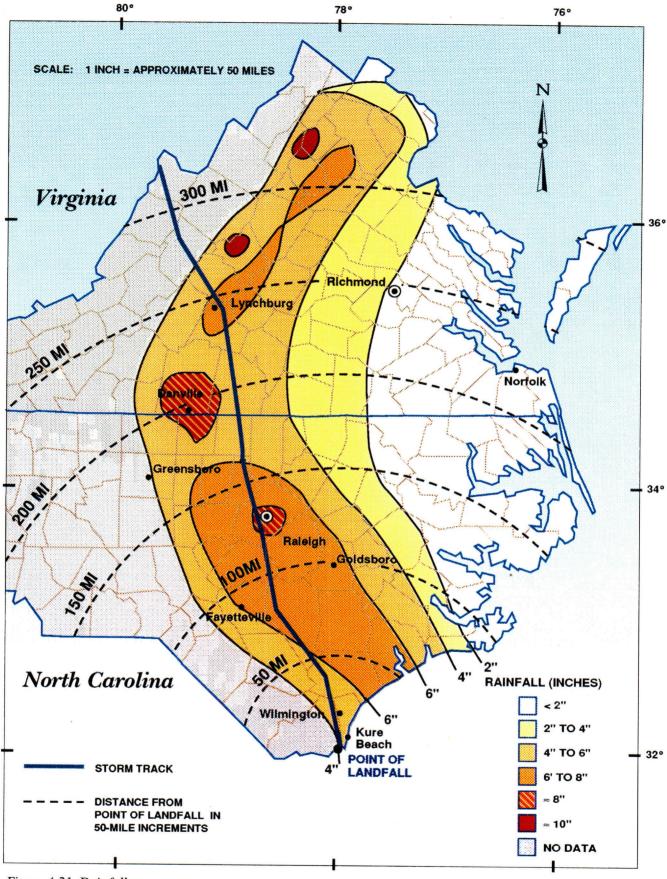
Figure 4-31 Rainfall.

Hurricane Fran produced record rainfall totals from the coast to Raleigh, North Carolina. Rainfall intensity was high both along and to the right of the storm track. The intense rain created flash floods in the Raleigh-Durham area that washed out roads, bridges, and dams. The storm created many other flash floods in the Virginia and West Virginia mountains. Wintergreen, Virginia, received 10.72 inches of rain. The flooding caused the Potomac River to crest 18 feet above flood stage at Harper's Ferry, West Virginia. The 100-year flood levels were exceeded in many communities. Figure 4-31 shows the rainfall totals along the storm-affected area.

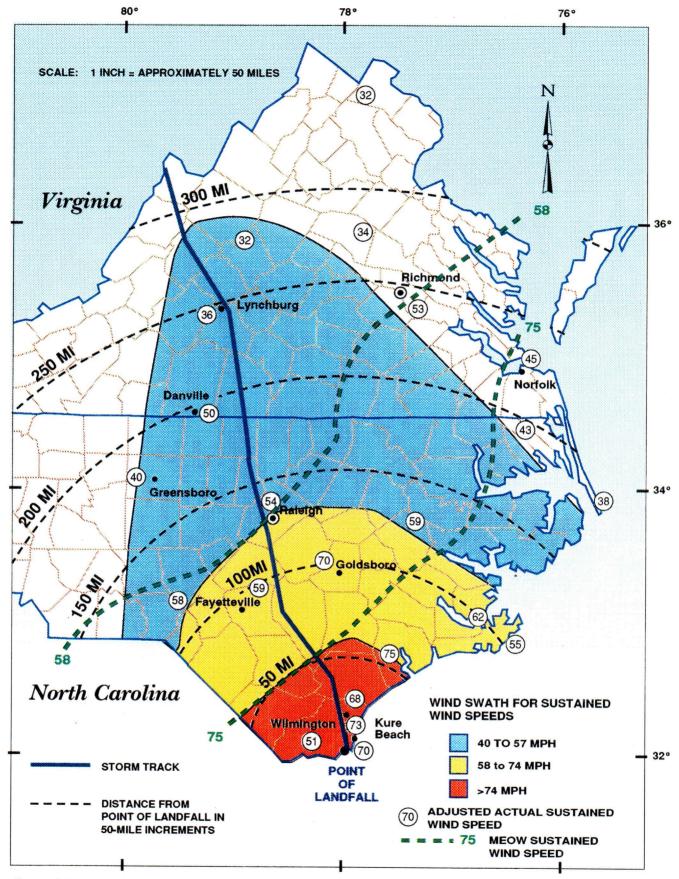
Figure 5-3 Hurricane Fran at tropical forecast advisory no. 49. MEOW and wind swath for sustained wind speeds based on a sustained wind speed of 98 mph at landfall and a forward speed of 14 mph.

When the evaluation of the Inland Wind Model is based on a landfalling speed of 98 mph (shown in Figure 5-3), which is closer to the actual sustained speed at landfall of 90 to 100 mph, all of the model's wind fields have a recorded sustained wind speed that falls within the defined field. Figure 5-4 shows the peak gusts compared to the wind fields of a 98-mph landfalling storm.
